Foliar Penetration of a Fungicide as Detected by Scanning Electron Microscopy and Energy Dispersive X-Ray Analysis

C. R. Krause

United States Department of Agriculture

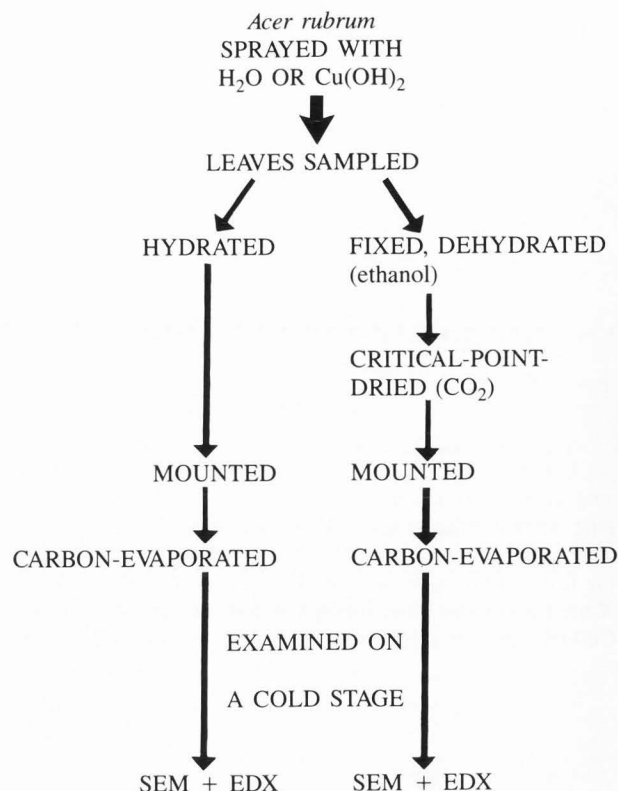
Figure 1. Specimen preparation procedures used in this study.

The SEM was operated at 25 kV, tilt angle of 30°, take off angle of 61°, 400 sec of exposure and mapping at 0.01 sec/point using the x-ray display program from the manufacturer. Specimen preparation procedures are outlined in Figure 1.

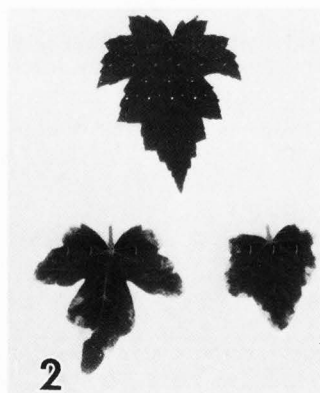
Figure 2. Top, red maple leaf sprayed with H₂O. Bottom, leaves sprayed with Cu(OH)₂ showing marginal necrosis.

Red maple leaves sprayed with H₂O did not exhibit lesions or necrosis but appeared turgid and vigorous as shown in Figure 2 (top leaf). For brevity and a reduction in the number of figures either micrographs of unfixed, hydrated specimens or micrographs of fixed, dehydrated specimens, (but not both) are used to describe the results of this experiment. Minor problems of surface structure collapse occurred in unfixed, hydrated specimens. When examined with SEM, top hydrated leaf surfaces had smooth epicuticular wax (Figure 3) and were similar to those described by Krause (4). Bottom hydrated surfaces (Figure 4) sprayed with H₂O had downy-like epicuticular wax with turgid, convex epidermal cells. EDX analysis revealed occasional particles containing silicon (Si) and calcium (Ca). Figure 5, a cross-section from a dehydrated leaf, showed various cell types as noted by Krause (5). Figure 6 shows a typical EDX spectrum from an *A. rubrum* leaf that was sprayed with H₂O. Endogenous elements were present as follows: Mg, Si, P, S, Cl, K, Ca and Fe. There were no obvious differences between the elemental composition of various cell types in the leaf.

Marginal necrosis began to be visible after two weeks on leaves sprayed with Cu(OH)₂, as shown at the bottom of Figure 2. Particles of Cu detected with SEM and EDX (Figures 7-15) on upper hydrated surfaces were uniformly distributed on leaves sprayed with Cu(OH)₂. Crystals were dispersed as shown in Figure 7. EDX indicated that Cu was present in the crystals as noted by the typical spectrum in Figure 8. X-ray dot mapping (Figure 9) verified the presence of Cu in the crystals. Aggregated crystals of Cu were visualized on the lower surfaces of leaves (see arrows in Figure 10) sprayed with Cu(OH)₂. Closer observation (Figure 11) indicated that these particles were loosely arranged and did not appear to be single, large crystals, but many smaller particles. Cu was detected in particles by EDX dot mapping (Figure 12). The variation in distribution of Cu between upper and lower surfaces and the difference in the texture of the epicuticular wax configuration are noteworthy. Perhaps the smooth upper leaf surface is more hydrophilic than the rough lower surface.

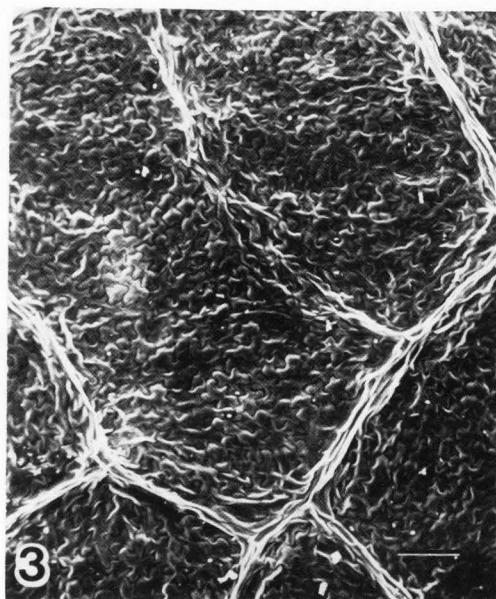
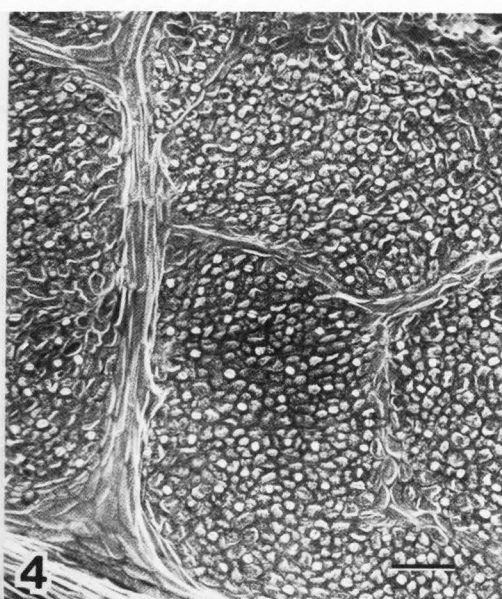
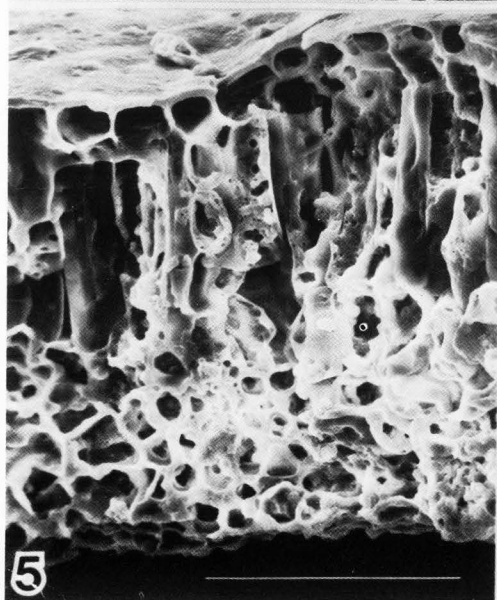
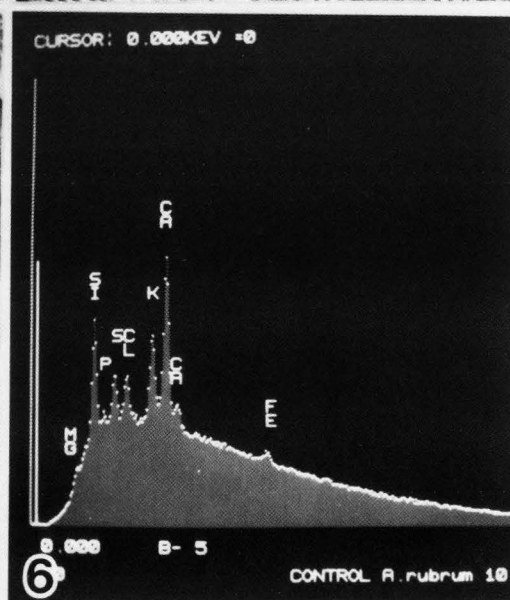
Figures 3-5. Scanning electron micrographs of unfixed, hydrated red maple leaves sprayed with H₂O. Figure 3. Upper surface with smooth epicuticular wax (bar=50μm). Figure 4. Bottom surface with downy-like epicuticular wax (bar =50μm). Figure 5. Cross-section showing various cell types (bar=50μm). Figure 6. Typical spectrum from H₂O-sprayed *A. rubrum*, leaf showing the endogenous elements Mg, Si, P, S, Cl, K, Ca and Fe.

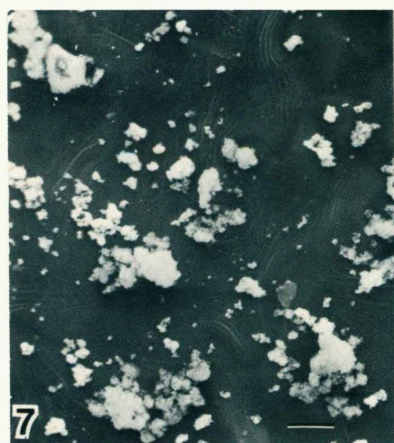
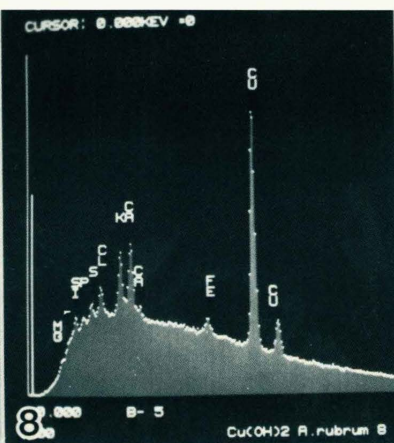
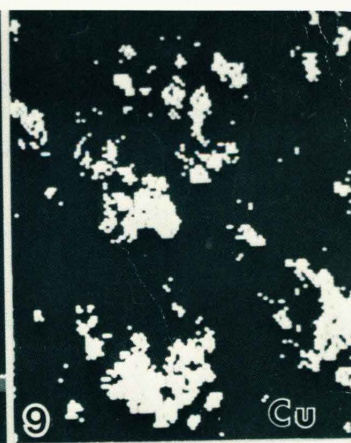
Figures 7-15. Red maple leaves sprayed with $\text{Cu}(\text{OH})_2$. **Figure 7.** Particles detected on upper surface, note uniform distribution. **Figure 8.** An energy dispersive X-ray (EDX) spectrum of the hydrated upper surfaces of the specimen of Figure 7 indicating the presence of Cu and other elements. **Figure 9.** X-ray dot map of Figure 7 showing actual Cu distribution in the particles.

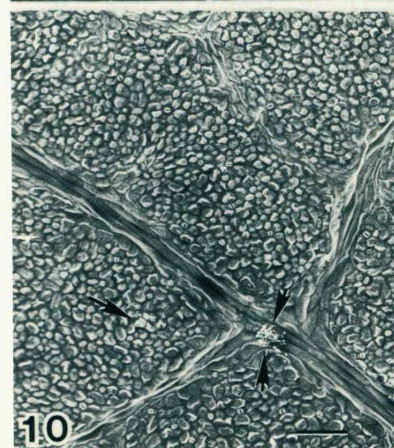
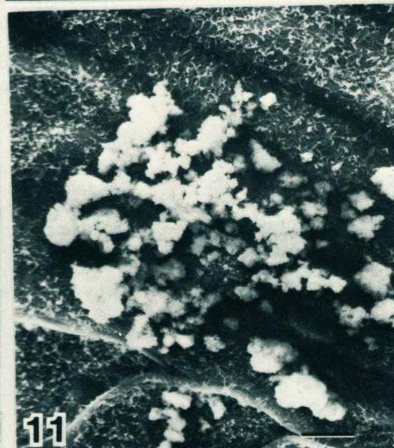
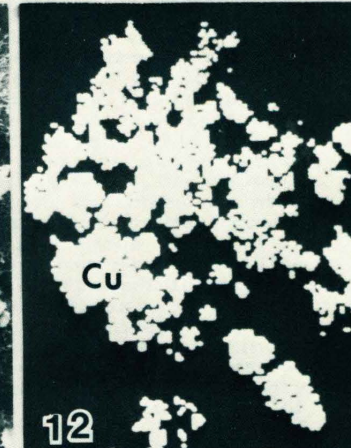
Figures 10,11. Lower hydrated surface showing a crystal identified as Cu with EDX.

Figure 12. X-ray dot map of Cu present in the particle of Figure 11.

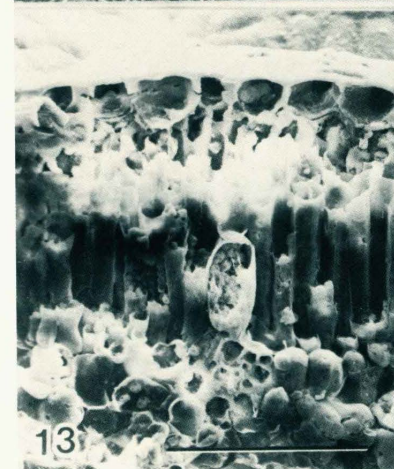
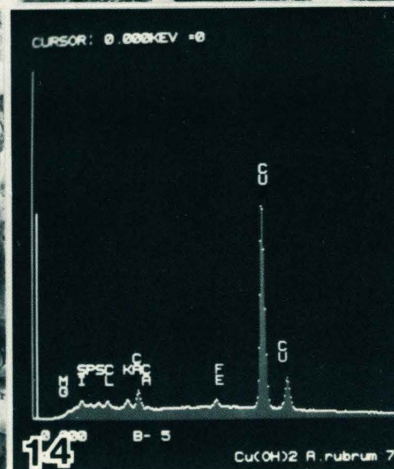
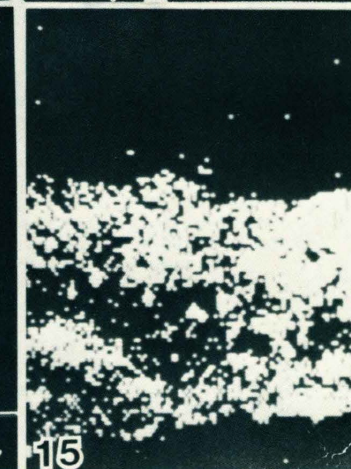
Figure 13. Cross-section from areas of marginal necrosis obtained with a razor blade. **Figure 14.** EDX spectrum of cross section of Figure 13 (note predominance of Cu). **Figure 15.** X-ray dot map of Cu present in cross-section of leaf that exhibited marginal necrosis (Figure 13). **Figures 7 and 10,** bars= $50\mu\text{m}$. **Figures 11 and 13,** bars= $5\mu\text{m}$.

When 20 dehydrated leaf cross-sections from areas of marginal necrosis were examined with SEM (Figure 13), Cu was detected in mesophyll cells in all sections as noted by a typical spectrum (Figure 14) and X-ray dot mapping (Figure 15). X-ray analysis of non-necrotic areas failed to show the presence of Cu.
